AMD-K6[®]

Processor Revision Guide

Model 6

Publication # 21266 Rev: G Amendment/ 0 Issue Date: August 1998
--

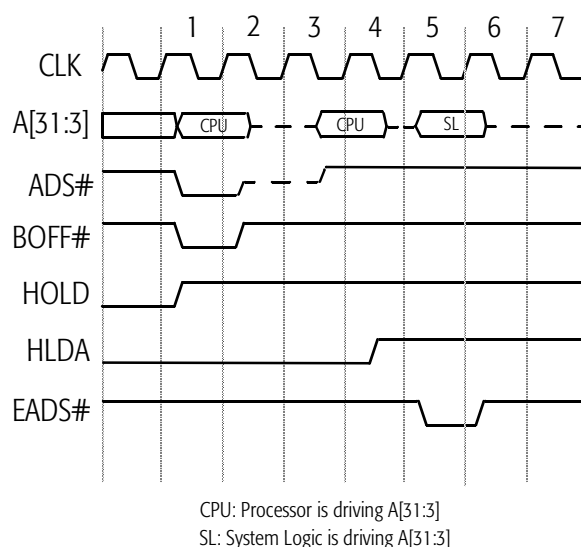
Figure 1. AMD-K6[®] Processor Assertion of HLDA Due to Simultaneous BOFF#/HOLD Assertion

Non-conformance. If BOFF# and HOLD are sampled asserted on the same clock edge that negates ADS#, the processor asserts HLDA two clock edges after HOLD is sampled asserted.

- If the system logic asserts BOFF# for a duration of one clock, anticipates the assertion of HLDA in clock 3 (see Figure 1)—which is the normal specified operation—and drives the address bus and EADS# for an inquire cycle in clock 3, then the processor will not sample EADS# asserted. In addition, address bus contention will occur in clock 3.

- If the system logic asserts BOFF# for a duration of two clocks, anticipates the assertion of HLDA in clock 3, and drives the address bus and EADS# for an inquire cycle in clock 3, then the processor will not sample EADS# asserted. (No address bus contention occurs in this case.)

- If the system logic asserts BOFF# for a duration of one clock, anticipates the assertion of HLDA in clock 3, and drives the address bus and EADS# for an inquire cycle in clock 4, then address bus contention may occur in clock 4. (The processor will sample EADS# asserted in this case.)

If the processor does not sample EADS# asserted during an inquire cycle, cache/memory incoherency will occur. Address bus contention can affect the reliability of the processor and the system logic.

Suggested Workaround. The system logic must sample the assertion of HLDA before asserting EADS# and driving the address bus for an inquire cycle—as shown in clock 5 of Figure 1.
