# **AMD-K6<sup>®</sup>**

## **Processor Revision Guide**

### **Model 7**

Publication # <b>21846</b> Rev: <b>H</b> Amendment/ <b>0</b> Issue Date: <b>June 1999</b>
----------------------------------------------------------------------------------------------

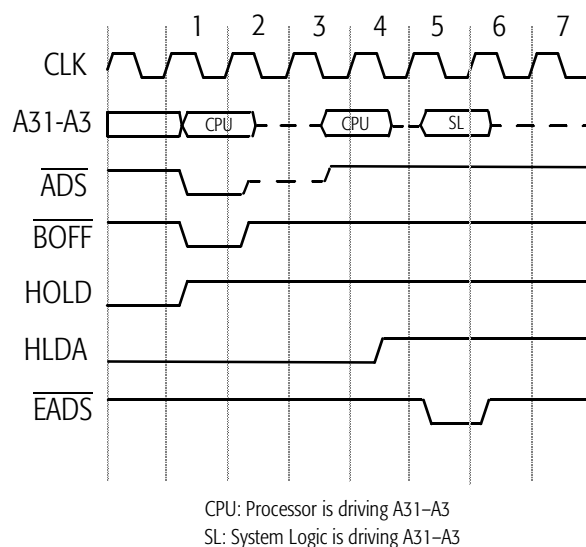
**Figure 1. AMD-K6<sup>®</sup> Processor Assertion of HLDA Due to Simultaneous  $\overline{\text{BOFF}}$ /HOLD Assertion**

**Non-conformance.** If  $\overline{\text{BOFF}}$  and HOLD are sampled asserted on the same clock edge that negates  $\overline{\text{ADS}}$ , the processor asserts HLDA two clock edges after HOLD is sampled asserted.

- If the system logic asserts  $\overline{\text{BOFF}}$  for a duration of one clock, anticipates the assertion of HLDA in clock 3 (see Figure 1)—which is the normal specified operation—and drives the address bus and  $\overline{\text{EADS}}$  for an inquire cycle in clock 3, then the processor will not sample  $\overline{\text{EADS}}$  asserted. In addition, address bus contention will occur in clock 3.

If the processor does not sample  $\overline{\text{EADS}}$  asserted during an inquire cycle, cache/memory incoherency will occur. Address bus contention can affect the reliability of the processor and the system logic.

**Suggested Workaround.** The system logic must sample the assertion of HLDA before asserting  $\overline{\text{EADS}}$  and driving the address bus for an inquire cycle—as shown in clock 5 of Figure 1.
