Issue Alert Letter #26

A small number of Portégé 650CT users have reported what would appear to be a display-related problem. When the unit is powered on, a long beep (approximately 2 seconds) is sounded by the system. The unit will appear to be booting properly, but the display will remain dark. Closer inspection of the screen reveals that characters or Windows screens are actually being displayed, but they remain dark.

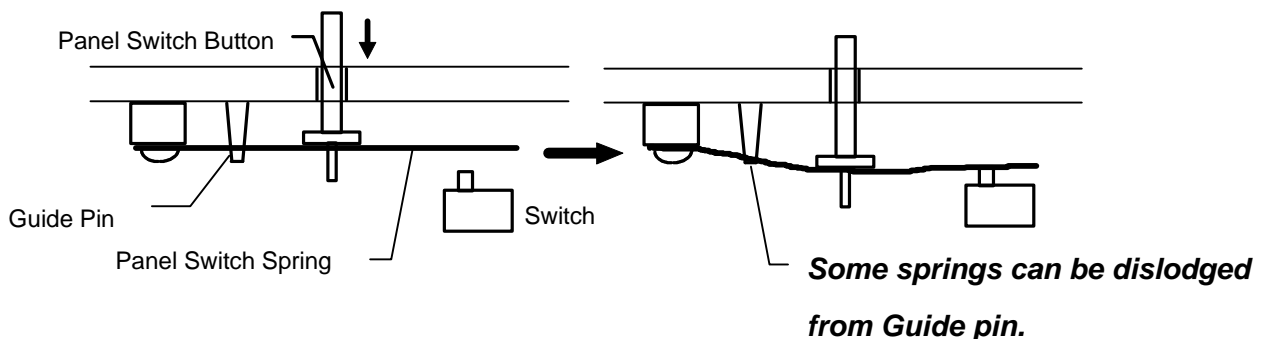
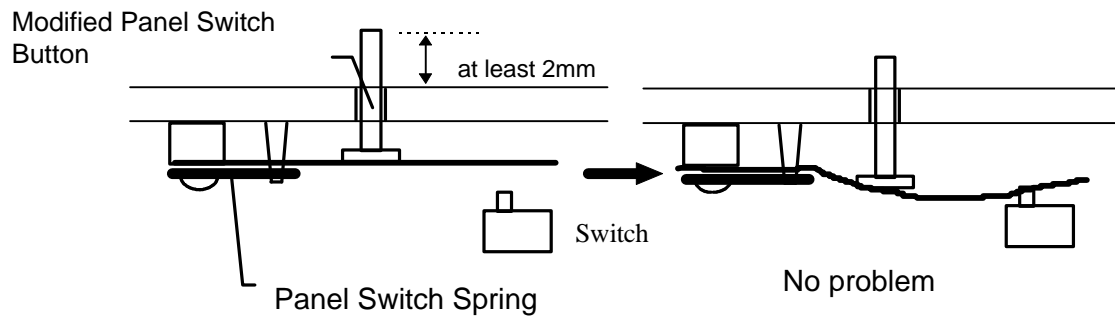
This symptom is caused by the Panel Switch Button getting stuck in the down position. The computer thinks that the display assembly is closed, so power is saved by not turning on the fluorescent tube on the display. The Panel Switch Button is the small plunger located just above the "F3" key.

Two changes have been made to the panel switch assembly to prevent the button from binding. A Panel Switch Spring Plate was added to the assembly to prevent the switch spring from becoming dislodged from a guide pin. The Panel Switch Button was also modified. A pin at the bottom of the button was removed to eliminate binding with the switch spring. Refer to the drawings below.

The part number for the new Panel Switch Spring Plate is P000227690. The part number for the modified Panel Switch Button is P000227080; however, the current button can be modified by simply removing the pin at the bottom of the button. The new parts will not be available for a few weeks.
