Chapter 13. 5126 Technician Terminal

Figure 13-1. IBM 5126 Technician Terminal

The 5126 is a Personal Computer AT-based product developed as a special bid for General Motors (GM) and designed to GM specifications for use in its service bay environment. The 5126 will be sold to Electronic Data Systems (EDS), a subsidiary of GM, which will market the 5126 to the GM dealerships.

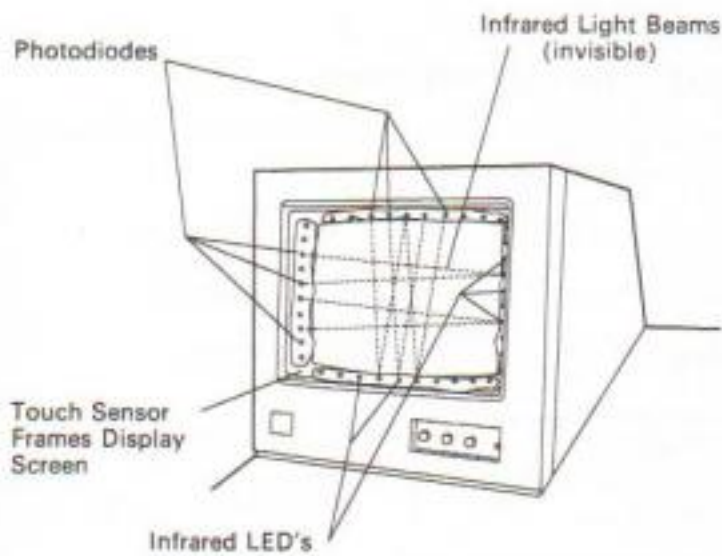
Figure 13-3. Touch Sensor Input System

The touch sensor is an infrared-transparent frame that mounts to the front of the enhanced graphics display. The touch sensor produces a lattice of infrared beams just in front of the surface of the monitor. These infrared beams are obstructed whenever the monitor screen is touched. The coordinates of the touched location are transmitted to the Personal Computer AT controller via the touch controller located on the Assembly Line Data Link (ALDL) card.

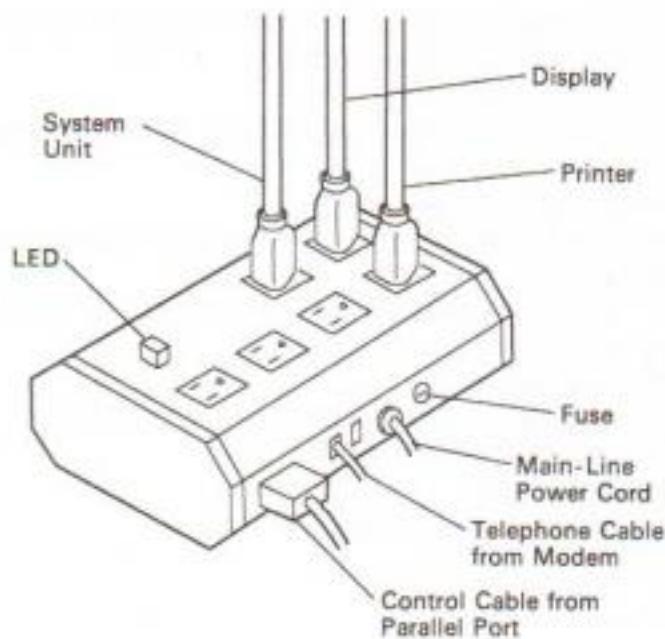
Figure 13-4. Power Control Device

The power control device is used for power distribution and has remote power-on capabilities. The power control device contains the following: one current sensing receptacle, one CPU receptacle, four peripheral receptacles, two phone line jacks, and a 25-pin D connector. For power distribution, the color monitor plugs into the current sensing receptacle. When the display is powered on, it causes all other devices plugged into the power control device also to power on. To receive service updates and transmit repair data to the GM Information Center, the GM service technician would connect the 5126 to a telephone line after his normal workday. A ring signal will cause the power control device to power up the 5126. After all information has been communicated, the power control device will power down the 5126 when the phone line goes to an On-Hook condition.

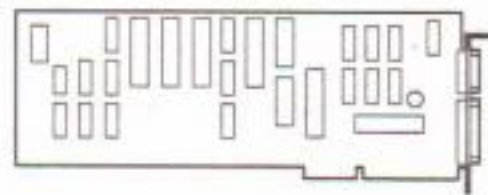
Figure 13-5. Assembly Line Data Link/Touch Adapter

The ALDL card occupies slot 5 of the system unit and interfaces with the automobile under test. The ALDL interface connector is located in the automobile under the dash near the steering column. This interface relays dynamic data to the 5126. This data is a real time presentation of the automobile's state. The 5126 then analyzes the data using stored values and specifications previously defined by GM service engineers. The ALDL card also contains an EPROM module for the touch controller hardware.

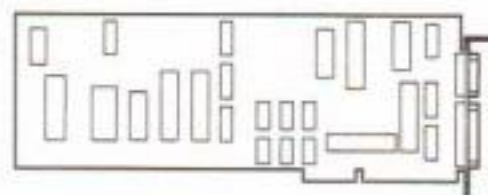
Figure 13-6. Probe Adapter Card

The Probe Adapter card is a multifunction attachment card located in slot 6 of the system unit. It allows a

GM service technician to further isolate a failure on a vehicle to a part or component that can be repaired, replaced, or adjusted. The functions performed by the Probe Adapter card are controlled by a service procedure interactively requesting the GM technician to take readings, inject source voltage/ground, or verify circuit paths as operational. The data obtained by the Probe Adapter card is presented to the GM service technician via the service procedure in visual or printed form for analysis.

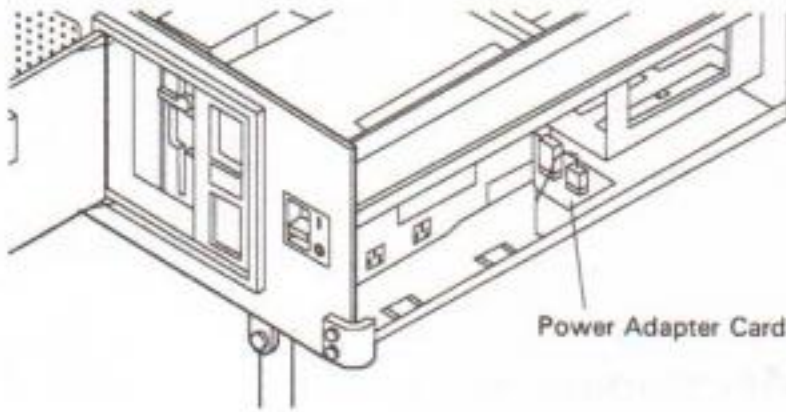
Figure 13-7. Power Adapter Card

The Power Adapter card is located between the rear of the power supply and the fixed disk drive. Its purpose is to provide additional power supply connections and to extend the power supply wires to the system board. There are no active electronic components on this card; it functions solely as a power distribution board for the power supply.

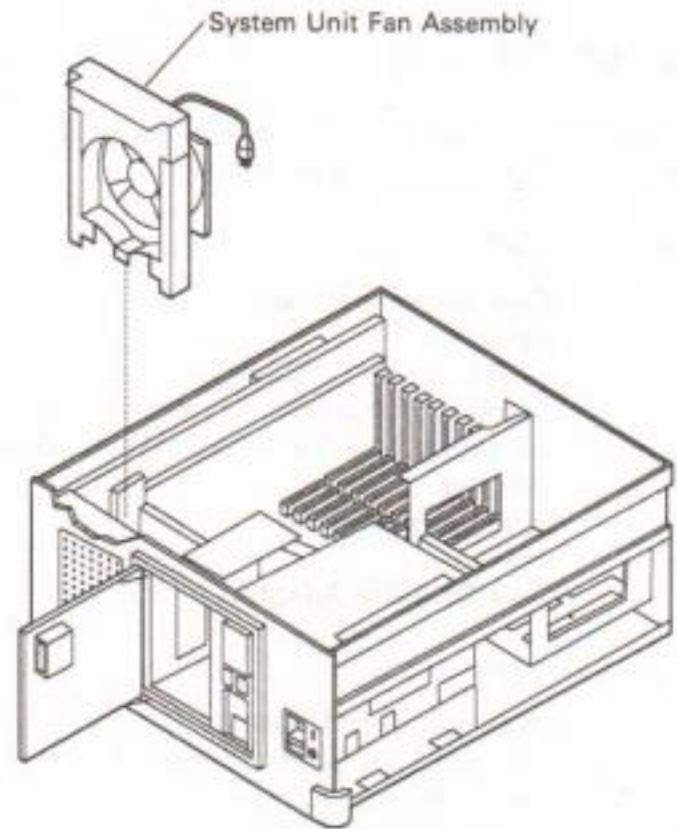
Figure 13-8. System Unit Fan Assembly

The system unit fan assembly contains a fan for additional air circulation and has a user-removable air filter. This filter protects the system unit from any particles that might enter and damage the system unit. The customer is responsible for cleaning and changing this filter, which fits into a slide-out filter retainer at the front of the system unit.

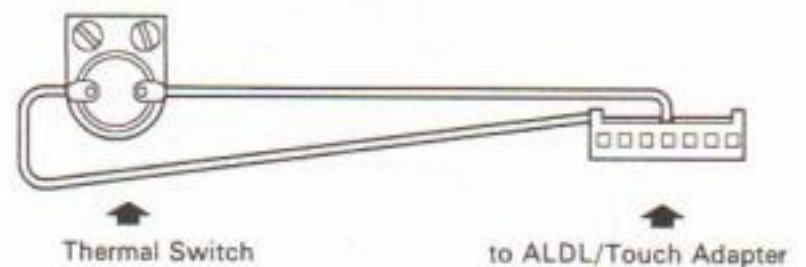
Figure 13-9. Thermal Switch

A thermal switch is located on the front of the disk drive mounting plate. Two wires connect the switch to a Berg connector on the ALDL/Touch Adapter. If the temperature gets too high in the system unit, this normally closed switch opens, producing a processing interrupt. This causes programming to issue a warning message on the display stating the 5126

internal temperature is too great and the air filter should be checked.

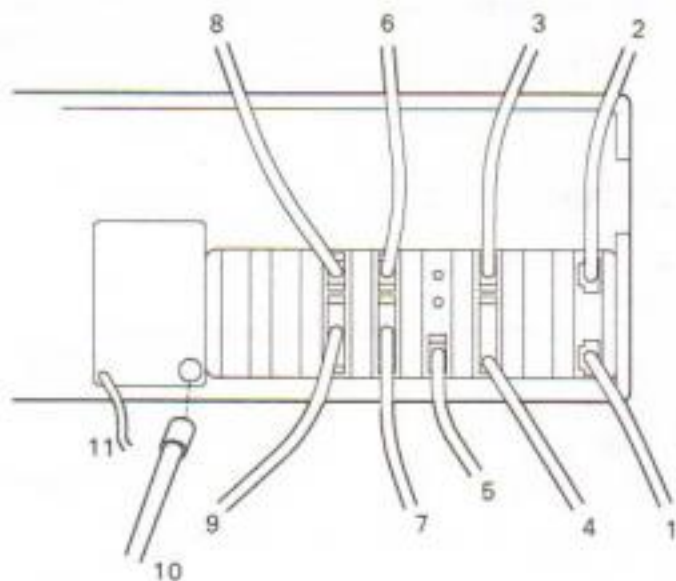
2. Telephone line out	Slot 1 - Internal Modem to PCD
3. Printer cable	Slot 3 - Serial/Parallel, Serial
4. PCD interface	Slot 3 - Serial/Parallel, Parallel
5. Enhanced Color Display	Slot 4 - Enhanced Graphics Adapter
6. Touch Sensor	Slot 5 - ALDL/Touch Adapter
7. ALDL cable	Slot 5 - ALDL/Touch Adapter
8. Battery cable	Slot 6 - Probe Adapter
9. Probe cable	Slot 6 - Probe Adapter
10. Keyboard cable	Keyboard connector through opening near keyboard connector
11. Speaker cable

Figure 13-10. System Unit Rear Panel Cables
